EXHIBIT L

REPORT FOR *AHERN v. SIG et al.***Factual Background**

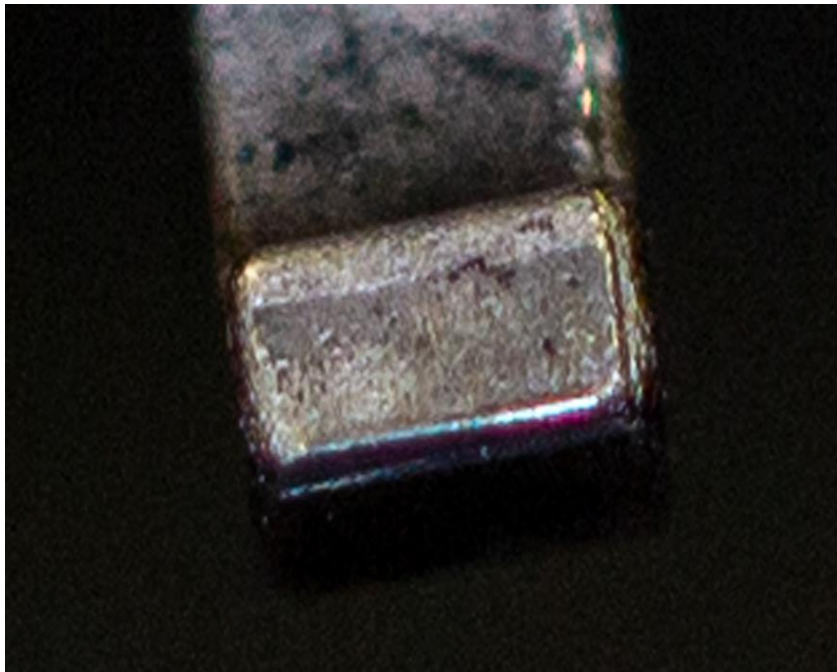
Ahern 0004E

6. The striker foot showed raised excess molding material along the outer perimeter of its “positive contact” area. This results in minimal engagement between the positive contact surfaces of the striker foot and sear face. It is important to note that this connection is spring charged, that is, the striker is under constant spring pressure to move forward past the sear to impact the primer of the chambered round. Minimal surface contact between these two surfaces combined with the shallow engagement of these small metal parts renders them susceptible to an uncommanded discharge upon an inertial impact to the gun as minor as an “impulse” as Sig itself has admitted, as is discussed below.

8. This excess material should have been removed from this part prior to its installation during the production process.

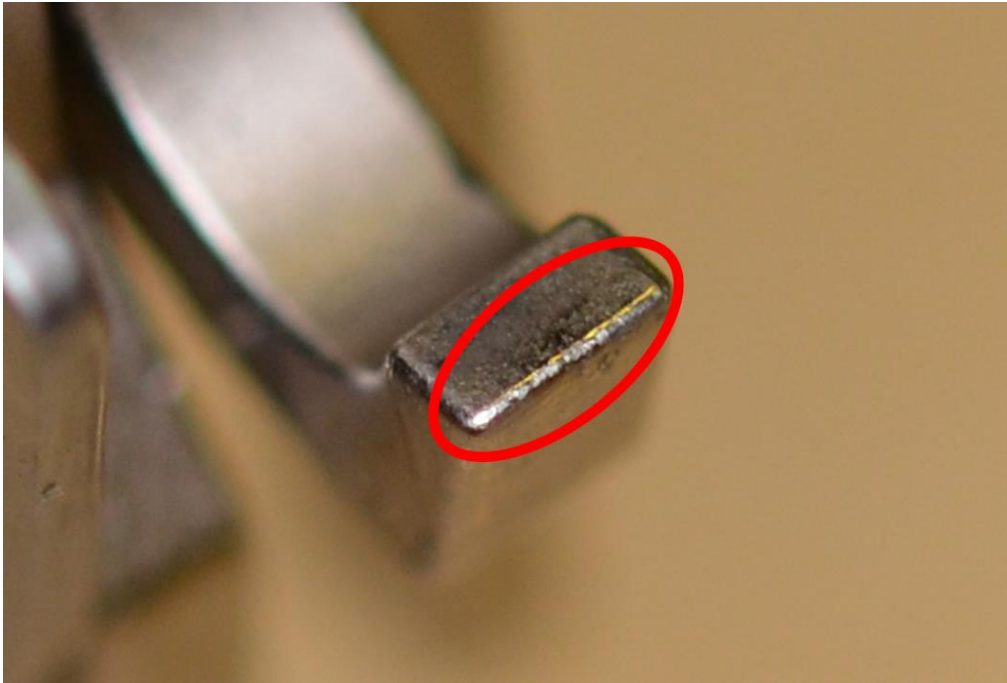
Jinn 0026E

7. The excess mold material present is consistent with several other striker foot examinations that I have conducted in previous cases as shown below.

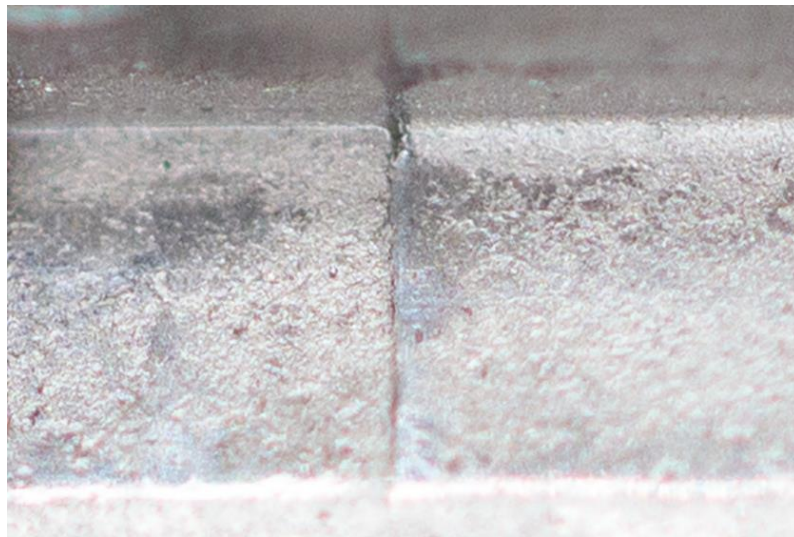
Ahern 0009E

9. An examination of the striker body shows a molding defect along the vertical striker wall and horizontal plane of the body which shows a drag mark that can cause the safety lock tab to jump up and over the striker stop as the striker travels forward during an uncommanded discharge.

10. This area is the “positive contact surface” that is supposed to interface with the safety lock tab should the striker travel forward uncommanded.

11. The lack of a flat positive contact surface of the striker wall can cause the safety lock tab to not properly engage the wall which is designed to prevent an uncommanded discharge.

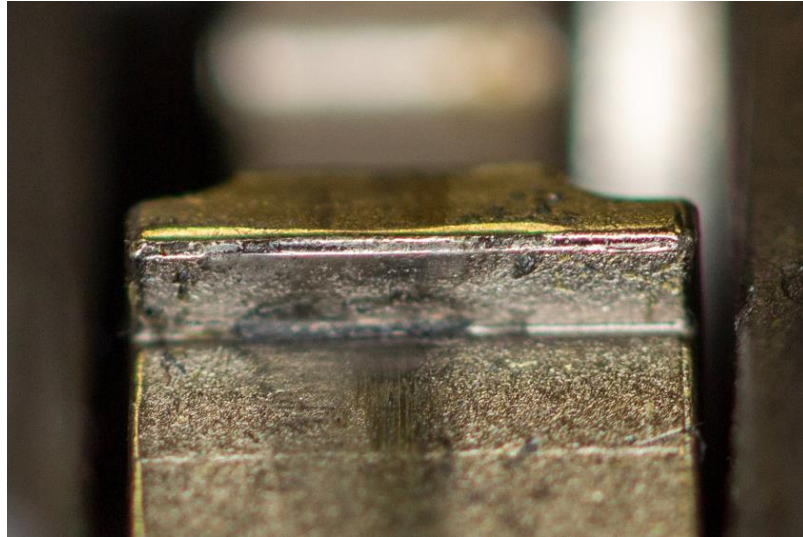
Ahern 0022E

12. Examination of the sear's "positive contact surface" also shows an uneven engagement surface.

13. Having raised excess material along the top horizontal portion of the sear prevents its positive contact surface (blackened area 0022E) from properly engaging and fully contacting the striker foot interface (0004E). Examination of the striker foot also shows excess mold material along the lower horizontal edge and right vertical side which, combined with the excess material on the sear, can prevent the positive contact surface of both parts to be fully engaged.

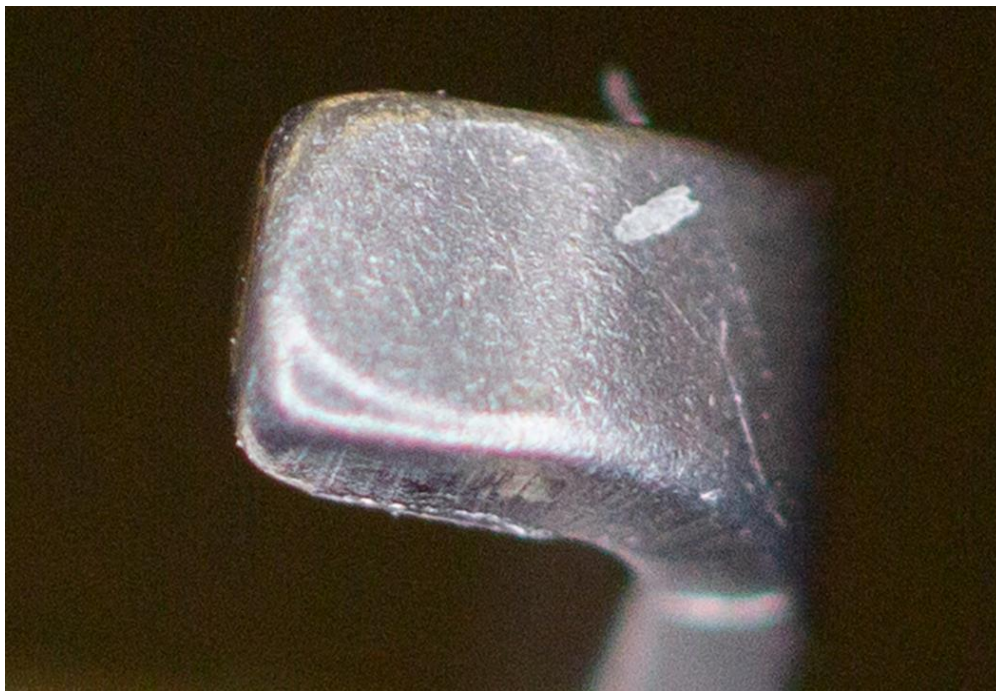
After removing the safety lock from the striker assembly, I was able to see that the tab was deformed and did not match the drawings of Sig Sauer's provided engineers' plans (below).

14. The safety lock is a stamped steel part where the tab portion is bent in a 90° turn horizontally to allow contact with the striker stop if the sear/striker engagement should fail. Also, along the bottom horizontal portion of the tab, there is an extended deformity protruding from the "positive contact surface" which again prevents a positive interface between the striker stop and safety lock tab should the sear/striker fail.

Ahern 0017E (Top view of tab showing rounded edging)

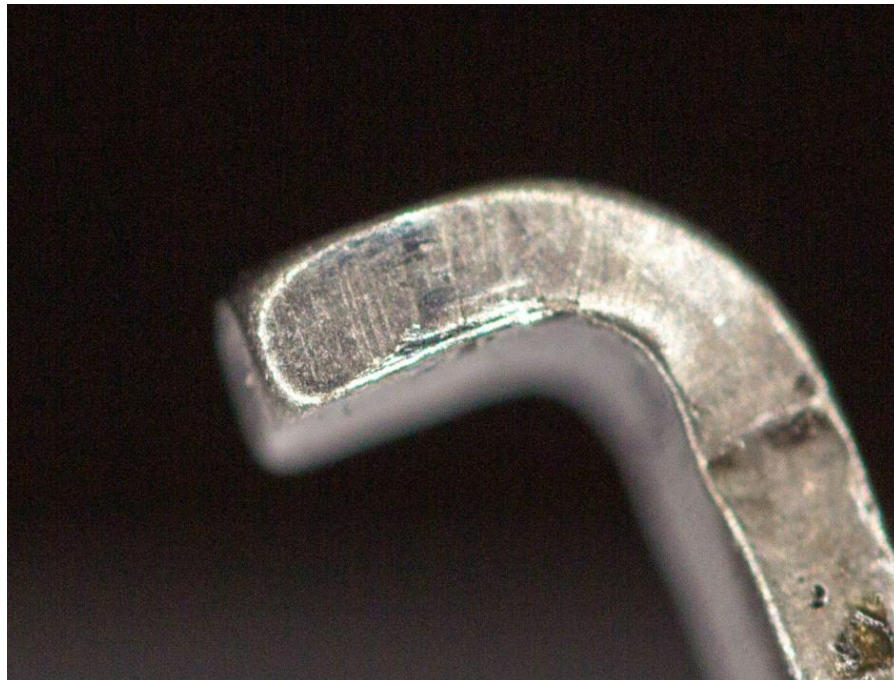
Hilton 0002 Raised edge of "Positive contact surface"

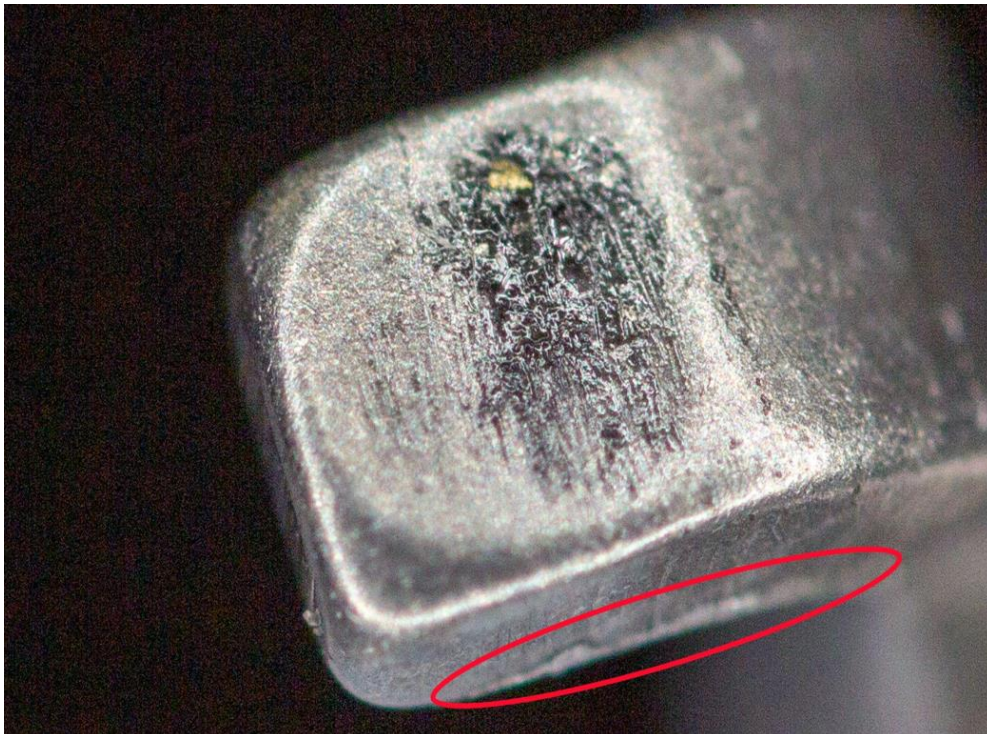
Hilton 0006

Hilton tab shares the same raised deformity along the bottom edge of the “positive contact” surface as Ahern (circled in red)

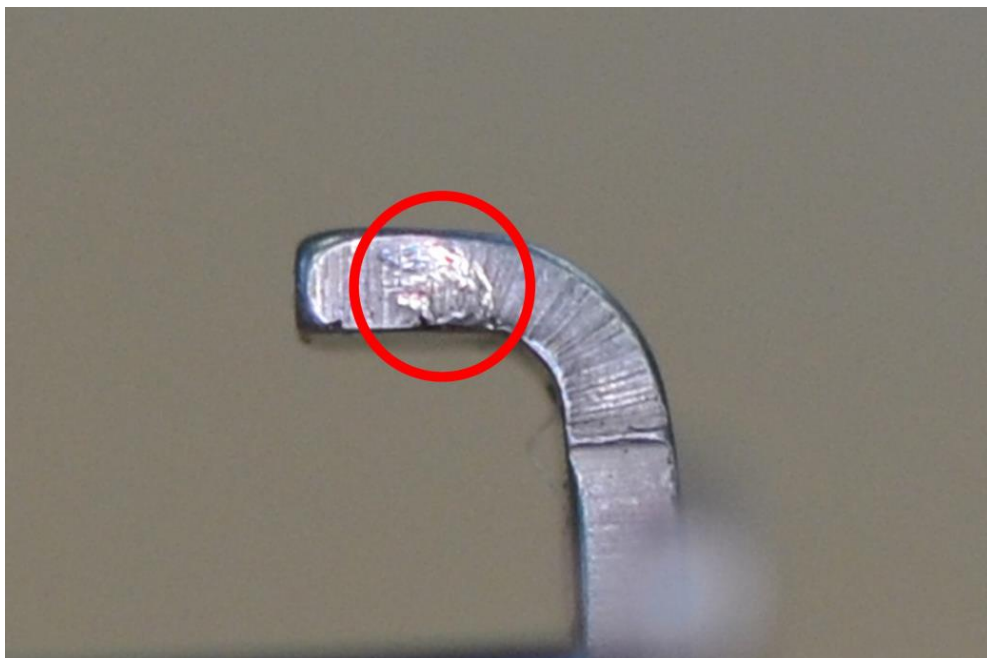
Perez 0032E Deformed bulge in center of tab

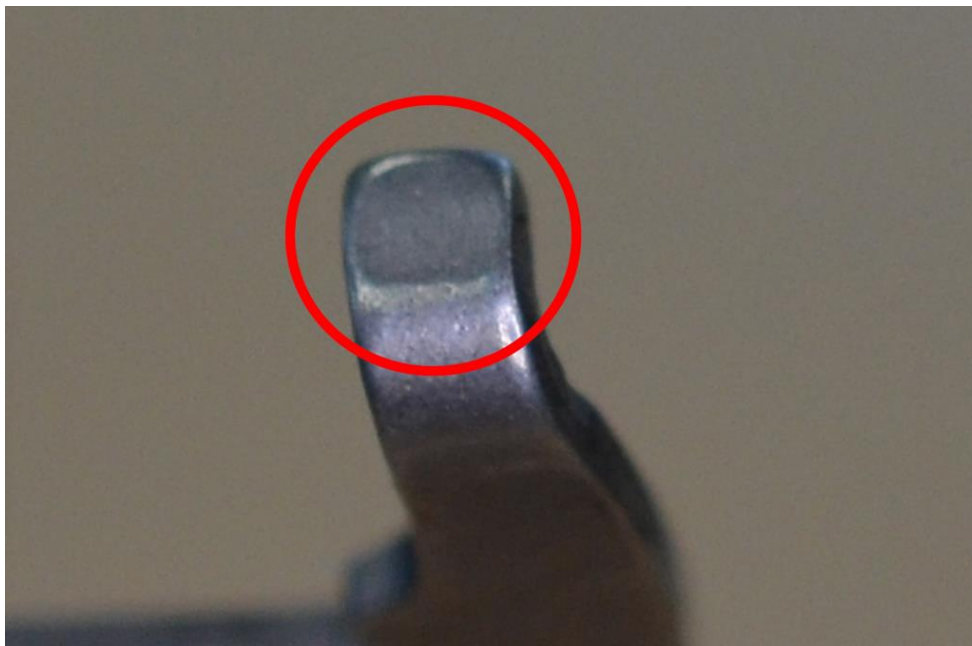
Perez 0034E Top view of tab showing rounded edging

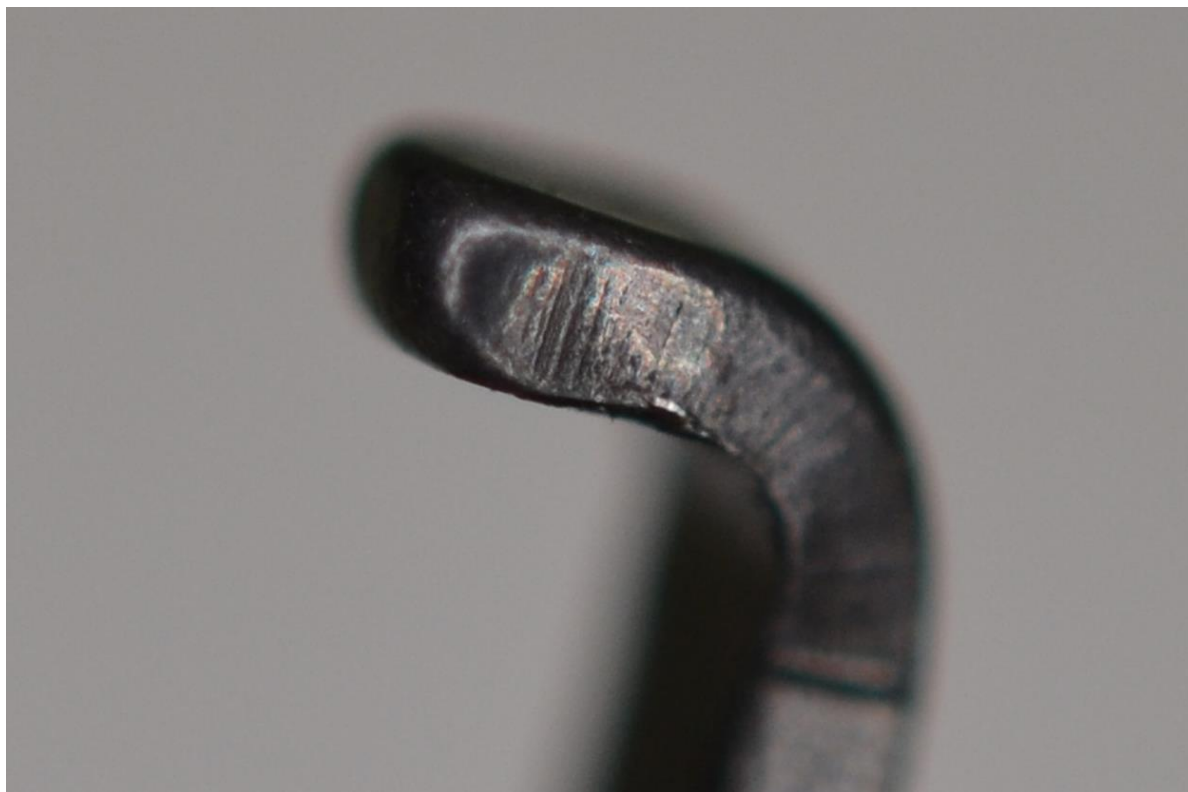
Exemplar 58C101498 PIC 00070E Raised edging along perimeter of tab

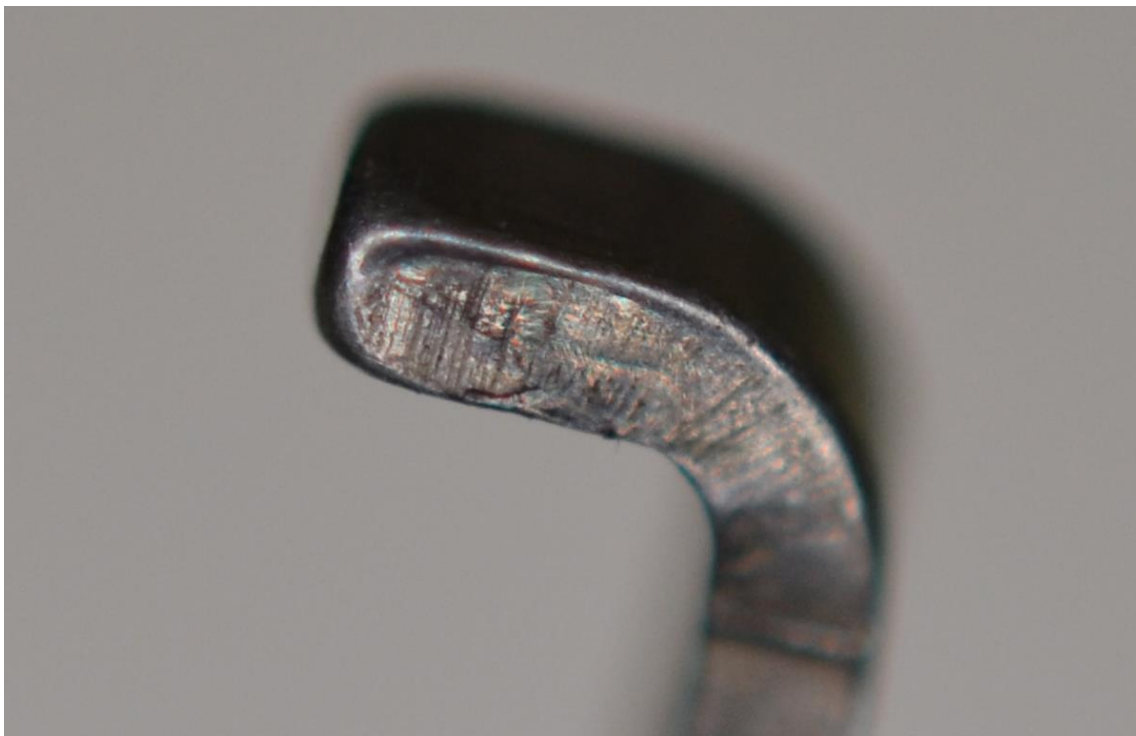
Exemplar 58C183837 PIC 0083E Raised edging along perimeter of tab

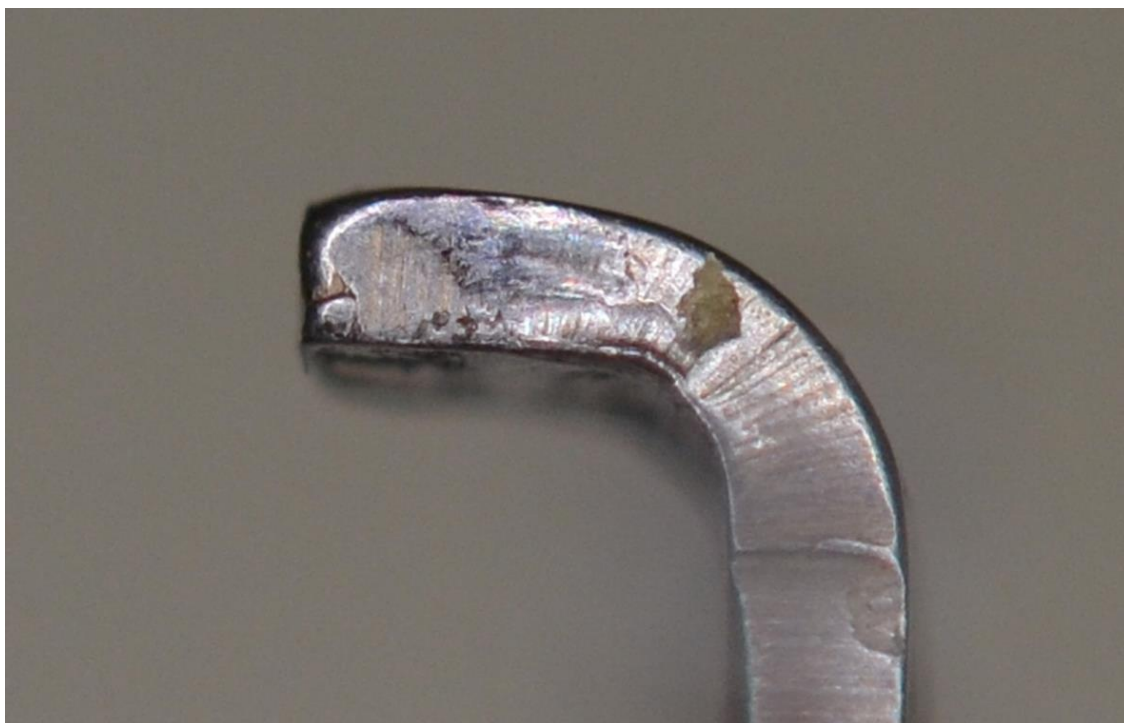
Frankenberry 58B017511 PIC 0060E Totally deformed “positive contact surface” of tab showing raised surface and fracture of metal
